Influence of defects size on the fatigue properties of an industrial EPDM

Thomas Balutch, Bertrand Huneau, Yann Marco, Pierre Charrier, Clément Champy. Influence of defects size on the fatigue properties of an industrial EPDM. 11th European Conference on Constitutive Models for Rubber (ECCMR 2019), Jun 2019, Nantes, France. 10.1201/9780429324710-62 . hal-02304552

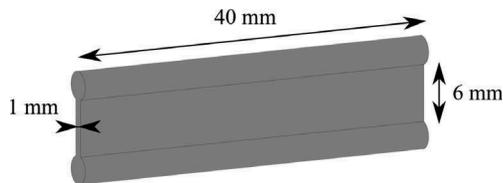
Figure 1. PS sample geometry.

Figure 2. Titanium drill of diameter 0.1 mm.

The samples used to perform the fatigue tests are Pure Shear (PS) samples with dimensions 6x40x1 mm (Figure 1). It has to be noted that this sample geometry is usually used for fatigue crack propagation measurements. It is chosen in this study because it is more convenient to introduce calibrated defects in this geometry and to monitor fatigue cracks around them than it is on 3D specimens. In order to be representative of natural defects, the calibrated holes sizes must be in the same order of magnitude, which is approximately 0.1 mm (Balutch et al. 2018). The best way to perform a 1 mm deep defect of such a size is drilling. Consequently, small drills made of titanium alloy (Figure 2), provided by Mikron Tool, are used. The drilling is done in the glassy

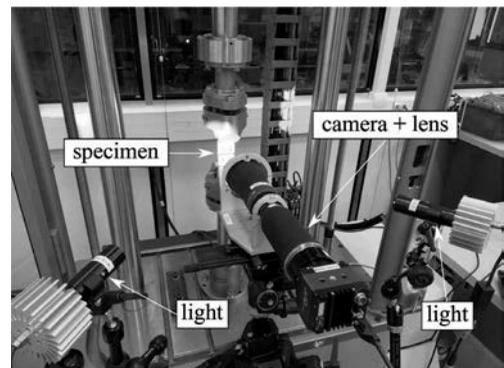
Figure 3. Experimental device.

In order to analyze fatigue crack initiation and propagation around defects, the fatigue test is interrupted every 200 cycles. The sample is then stretched to 3 mm during 2 seconds and a picture is taken. Therefore, a camera is installed in front of the specimen, and is triggered by the tensile machine (Figure 3).

The camera installed in front of the specimen is a Prosilica GT6600 from Allied Vision with a resolution of 6576*4384 pixels, and a bi-telecentric lens TC16M056 from OPTO engineering is used. The size of the pixel is equal to 8.55, and the distortion is below 0.1 %. The crack detection highly depends on this resolution, and a different experimental device would lead to a slightly different split between crack

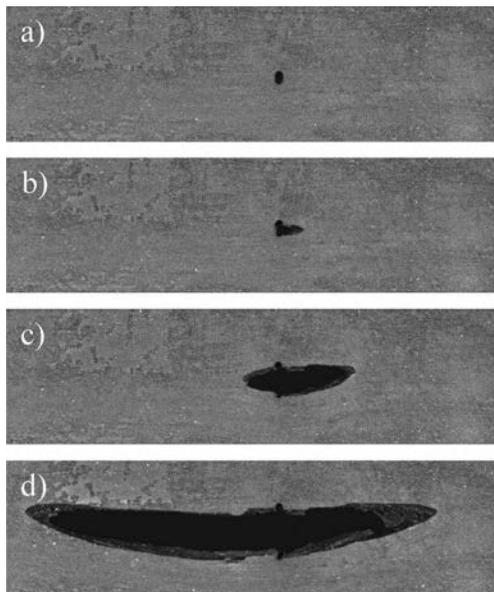
Figure 5. PS sample with a 0.2 mm hole at a) N = 0 cycle b) N = 109 400 cycles c) N = 112 600 cycles and d) N = 116 400 cycles.

Secondly, a damage description is proposed on Figure 5 thanks to regular pictures taken during fatigue tests. A first fatigue crack initiates on one side of the calibrated defect (Figure 4b), and few cycles later, another crack initiates on the opposite side (Figure 4c). They finally both propagate until final failure occurs. Figure 4d shows the sample just before failure. Each sample exhibits only one root cause of failure.

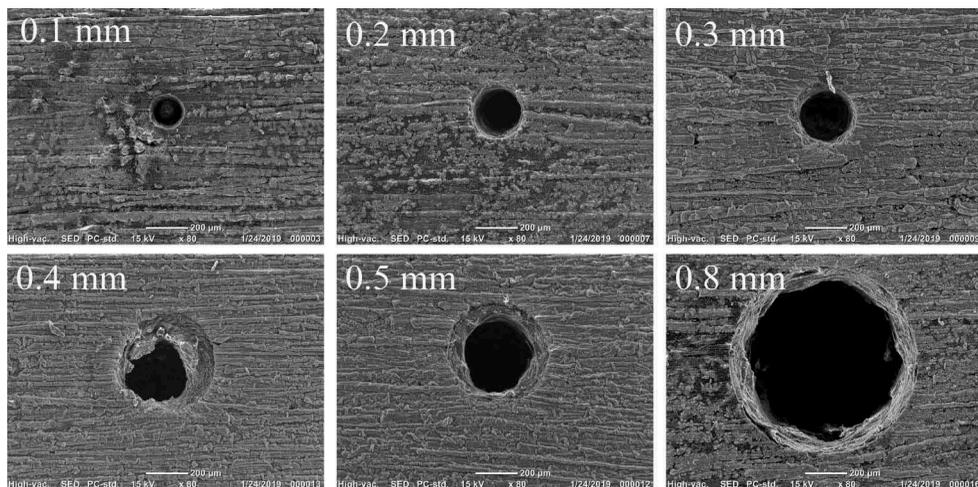
Figure 4. SEM pictures of the different hole sizes at the same magnification (x80).

In the first place, it has to be noted that small calibrated defects of good quality are successfully obtained. SEM pictures of all the tested defects sizes are presented in Figure 4. The rubber around the holes seems not burned or dragged by the drilling. This can only be obtained by performing the drilling in the glassy state of the rubber as mentioned in the methods section.

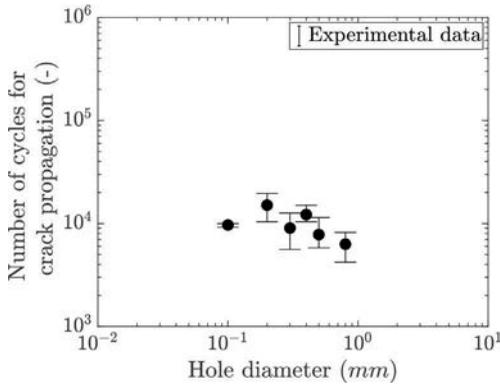
Figure 6. Hole diameter influence on the number of cycles for crack propagation.

given drill diameter. Figure 6 shows that the number of cycles for fatigue crack propagation is almost constant regardless of the hole diameter. In other words, as soon as a crack is visible, the number of cycles to propagate this crack until final failure is not much dependent on the defects size.

Another point is that Figures 6-7 prove that the total duration life is mainly driven by the fatigue “crack initiation” stage, the crack propagation stage being more or less constant for every samples. The strong influence of the defects size on Figure 6 suggests that the fatigue crack initiation stage must be studied to fully understand the fatigue behaviour of

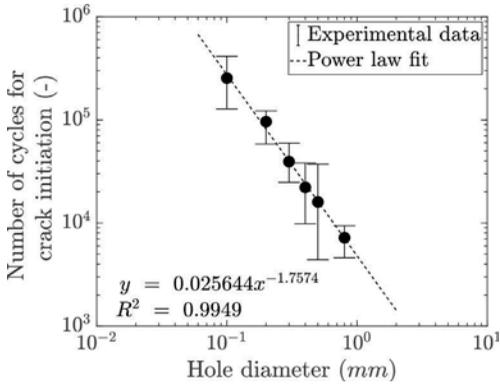
Figure 7. Hole diameter influence on the number of cycles for crack initiation.

Similarly, the Figure 7 represents the number of cycles for “crack initiation” as a function of the hole diameter. Unlike for propagation stage, it appears that the curve follows a decreasing power law with a good correlation coefficient. Thus, the bigger the size of the defect is, the shorter the number of cycles for “crack initiation” is, and this is in accordance with the literature (Huneau et al. 2016, Abraham et al. 2005).

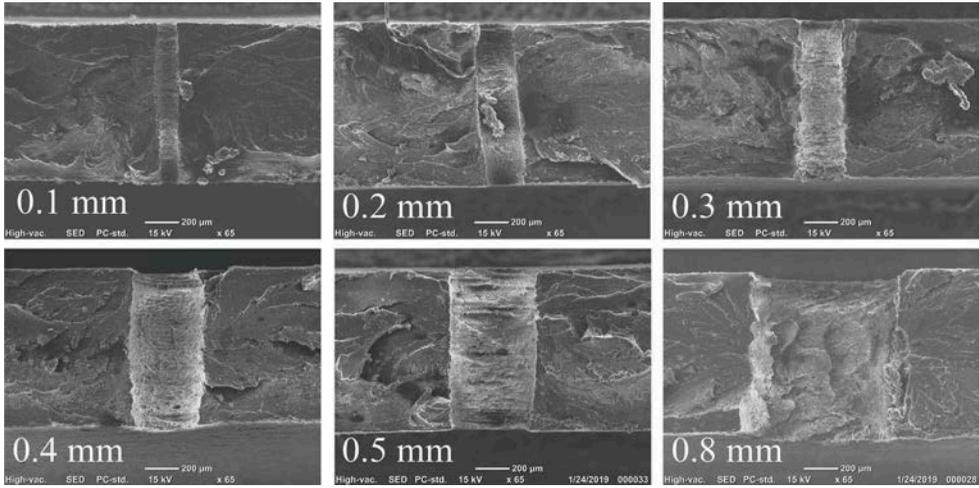
Figure 8. SEM pictures of fracture surfaces for each hole size at the same magnification (x65).

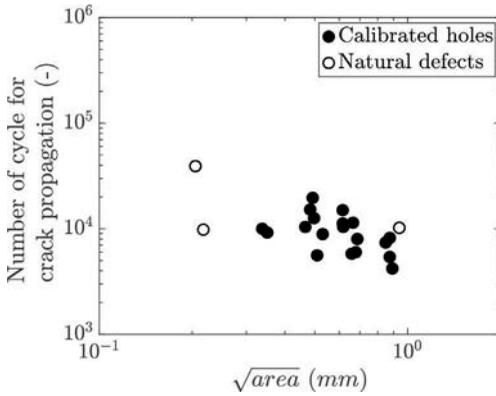
Figure 9. Defect $\sqrt{\text{area}}$ influence on the number of cycles for fatigue crack propagation.

Considering that geometrical features are the easiest parameters to quantify, the square root of the projected area in the tensile direction of the defect that led to failure is measured for all samples. This allows plotting on the same curve the results for natural defects and calibrated holes. It has been initially proposed by Murakami and Endo (1983), and is still used nowadays in fatigue of metals to represent the defects size (Houria et al. 2015, Le et al. 2016). This area is measured thanks to fracture surfaces analysis (Figure 8) and plotted versus the number of cycles for crack propagation (Figure 8) and the number of cycles for “crack initiation” on the Figure 10. The black points correspond to calibrated holes, and the black circles correspond to natural defects. The Figures 9-10 show that natural defects and calibrated holes seem aligned on one master curve. It appears that the defects size has a minor influence on crack propagation stage compare to crack initiation stage. Furthermore, Figure 9 shows that a variation of 1 decade in the \sqrt{area} of the defect responsible of the failure roughly leads to a variation of 2 decades in the number of cycles for fatigue crack initiation. Regarding the fatigue results of EPDM (Flamm et al. 2008, Balutch et al. 2018), it is common to observe more than 2 decades of scatter in the fatigue lifetime results. Hence, the variation of the defects size could explain a part of the scatter in the fatigue lifetime of such material.

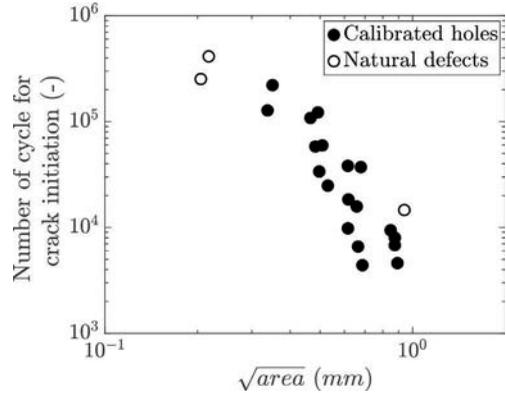
Figure 10. Defect $\sqrt{\text{area}}$ influence on the number of cycles for fatigue crack initiation.

This means that \sqrt{area} of the defect could be a good criterion to compare the defects size criticality. However, it must be reminded that these results are obtained for one load level only, and with a specific sample geometry. Furthermore, the validity of \sqrt{area} as representative of the defect size is questionable. Indeed, fatigue crack initiation is a local phenomenon and perhaps only a localized zone of the defect contributes to this stage. Moreover, two defects could have the exact same projected area with very different 3D shape, and a lot of other parameters previously mentioned could have a noticeable influence on the fatigue crack initiation and propagation stages. For all of these reasons, the use of \sqrt{area} requires further investigations.

Finally, in the literature concerning the fatigue of metals described in the introduction (Murakami and Endo 1980, Murakami et al. 1989, Billaudeau et al. 2004), it is shown that defects size have no influence anymore on the fatigue lifetimes below a certain size. The results obtained for the studied EPDM in Figure 10 only confirm an increasing duration life with decreasing size of defect. But no assumption can be made on how defects with $\sqrt{\text{area}}$ below 200 would influence the fatigue resistance. Also, a fundamental difference between rubbers and most of metallic materials is the absence of fatigue limit for rubbers, which could explain the absence of thresholds in the fatigue properties of rubbers. The possible existence of a plateau or the continuation of the slope on the left hand part of the Figure 9 remain open questions. In fact, the influence of these small defects sizes is very hard to investigate. Indeed, for
