Influence of defects size on the fatigue properties of an industrial EPDM

Thomas Balutch, Bertrand Huneau, Yann Marco, Pierre Charrier, Clément Champy. Influence of defects size on the fatigue properties of an industrial EPDM. 11th European Conference on Constitutive Models for Rubber (ECCMR 2019), Jun 2019, Nantes, France. 10.1201/9780429324710 . hal-02304552

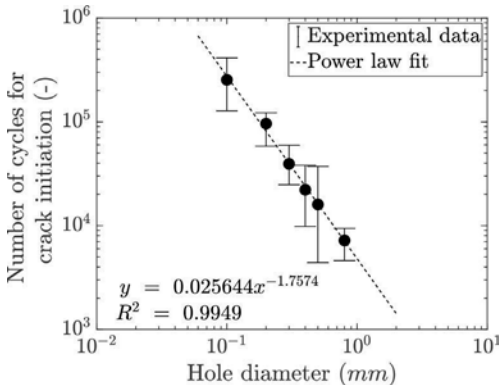
Figure 7. Hole diameter influence on the number of cycles for crack initiation.

Similarly, the Figure 7 represents the number of cycles for “crack initiation” as a function of the hole diameter. Unlike for propagation stage, it appears that the curve follows a decreasing power law with a good correlation coefficient. Thus, the bigger the size of the defect is, the shorter the number of cycles for “crack initiation” is, and this is in accordance with the literature (Huneau et al. 2016, Abraham et al. 2005).

Another point is that Figures 6-7 prove that the total duration life is mainly driven by the fatigue “crack initiation” stage, the crack propagation stage being more or less constant for every samples. The strong influence of the defects size on Figure 6 suggests that the fatigue crack initiation stage must be studied to fully understand the fatigue behaviour of

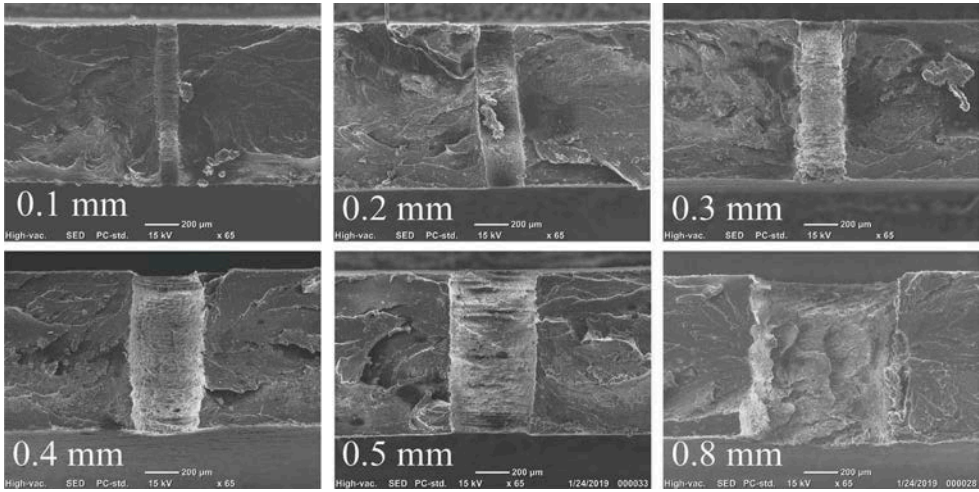
Figure 8. SEM pictures of fracture surfaces for each hole size at the same magnification (x65).

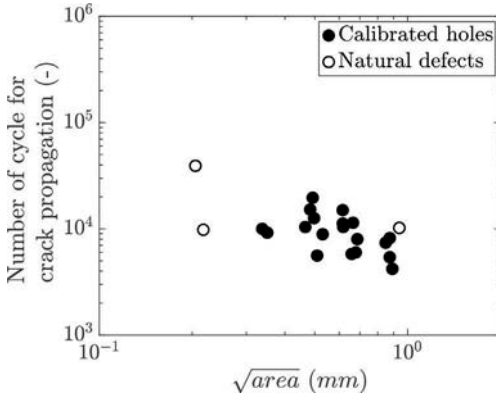
Figure 9. Defect $\sqrt{\text{area}}$ influence on the number of cycles for fatigue crack propagation.

Considering that geometrical features are the easiest parameters to quantify, the square root of the projected area in the tensile direction of the defect that led to failure is measured for all samples. This allows plotting on the same curve the results for natural defects and calibrated holes. It has been initially proposed by Murakami and Endo (1983), and is still used nowadays in fatigue of metals to represent the defects size (Houria et al. 2015, Le et al. 2016). This area is measured thanks to fracture surfaces analysis (Figure 8) and plotted versus the number of cycles for crack propagation (Figure 8) and the number of cycles for “crack initiation” on the Figure 10. The black points correspond to calibrated holes, and the black circles correspond to natural defects. The Figures 9-10 show that natural defects and calibrated holes seem aligned on one master curve. It appears that the defects size has a minor influence on crack propagation stage compare to crack initiation stage. Furthermore, Figure 9 shows that a variation of 1 decade in the \sqrt{area} of the defect responsible of the failure roughly leads to a variation of 2 decades in the number of cycles for fatigue crack initiation. Regarding the fatigue results of EPDM (Flamm et al. 2008, Balutch et al. 2018), it is common to observe more than 2 decades of scatter in the fatigue lifetime results. Hence, the variation of the defects size could explain a part of the scatter in the fatigue lifetime of such material.

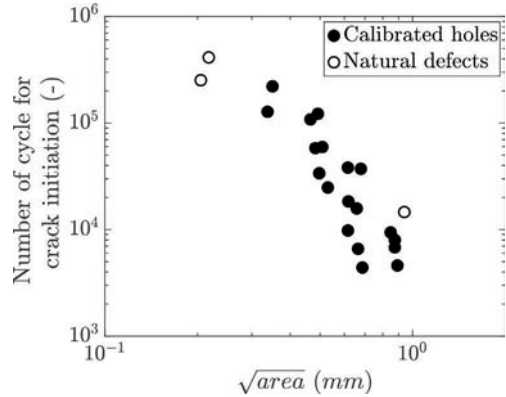
Figure 10. Defect $\sqrt{\text{area}}$ influence on the number of cycles for fatigue crack initiation.

Finally, in the literature concerning the fatigue of metals described in the introduction (Murakami and Endo 1980, Murakami et al. 1989, Billaudeau et al. 2004), it is shown that defects size have no influence anymore on the fatigue lifetimes below a certain size. The results obtained for the studied EPDM in Figure 10 only confirm an increasing duration life with decreasing size of defect. But no assumption can be made on how defects with $\sqrt{\text{area}}$ below 200 would influence the fatigue resistance. Also, a fundamental difference between rubbers and most of metallic materials is the absence of fatigue limit for rubbers, which could explain the absence of thresholds in the fatigue properties of rubbers. The possible existence of a plateau or the continuation of the slope on the left hand part of the Figure 9 remain open questions. In fact, the influence of these small defects sizes is very hard to investigate. Indeed, for
